TRANSPORTATION RESEARCH CENTER

ON-SITE AIR BAG INVESTIGATION

CASE NO. - 93-07

The 1990 Dodge Daytona was equipped with a driver supplemental restraint system (air bag) which did not deploy as a result of the right front impact. The driver of the vehicle (28 year-old female) was not wearing the available, active, three-point, lap and shoulder belt. The driver was ejected out the backlight and was found just west of the Daytona's final rest position. She sustained fatal injuries including multiple lower left rib fractures and a massive hemothorax (i.e., estimated at between 2000-3000 ccs) which resulted in cardio-pulmonary arrest from exsanguination. The driver of the Daytona was listed on the Police Accident Report as sustaining a "K" (fatal) injury as a result of her crash. The driver (33 year-old male) of the Fiero was listed on the Police Accident Report as restrained and sustaining an "A" (incapacitating) injury.

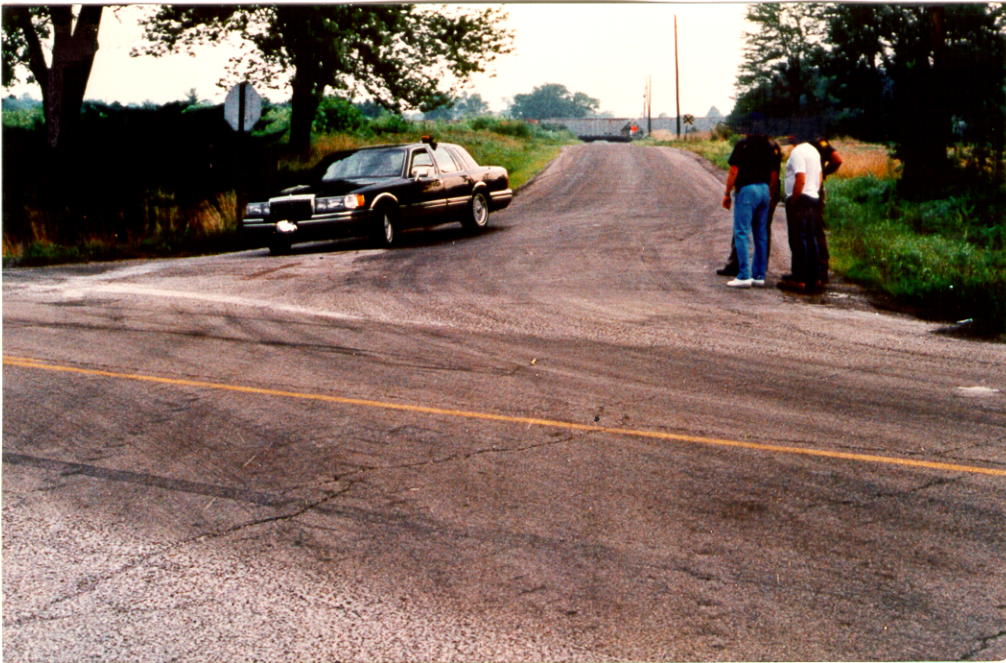
01 -- [REDACTED] 1993
 [REDACTED] Illinois
 TRC/IU: 93-07, Task: 0103
 ISP Photo: Daytona's north-
 ward approach to impact area

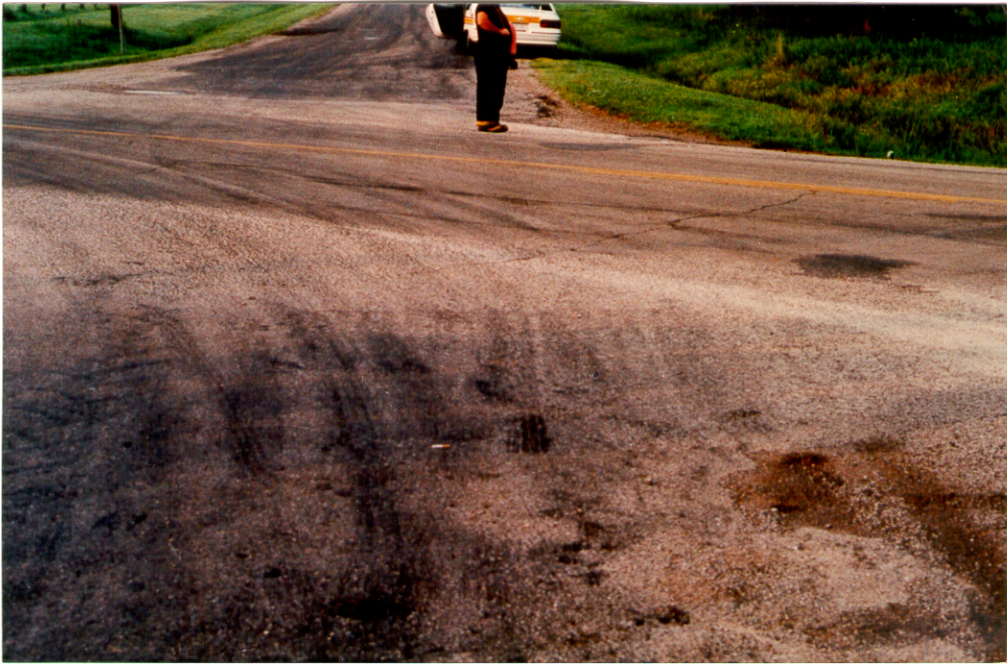
03 -- [REDACTED] 1993
 [REDACTED] Illinois
 TRC/IU: 93-07, Task: 0103
 ISP Photo: looking south
 opposite Daytona's approach

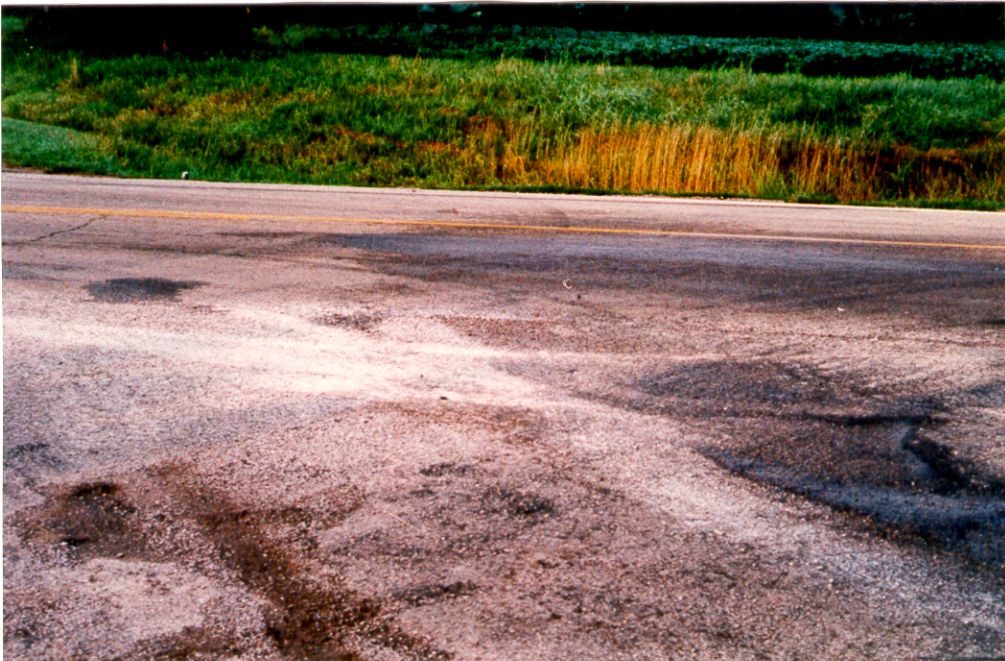
04 -- [REDACTED] 1993
 [REDACTED] Illinois
 TRC/IU: 93-07, Task: 0103
 ISP Photo: fluid spill west
 of intersection from north

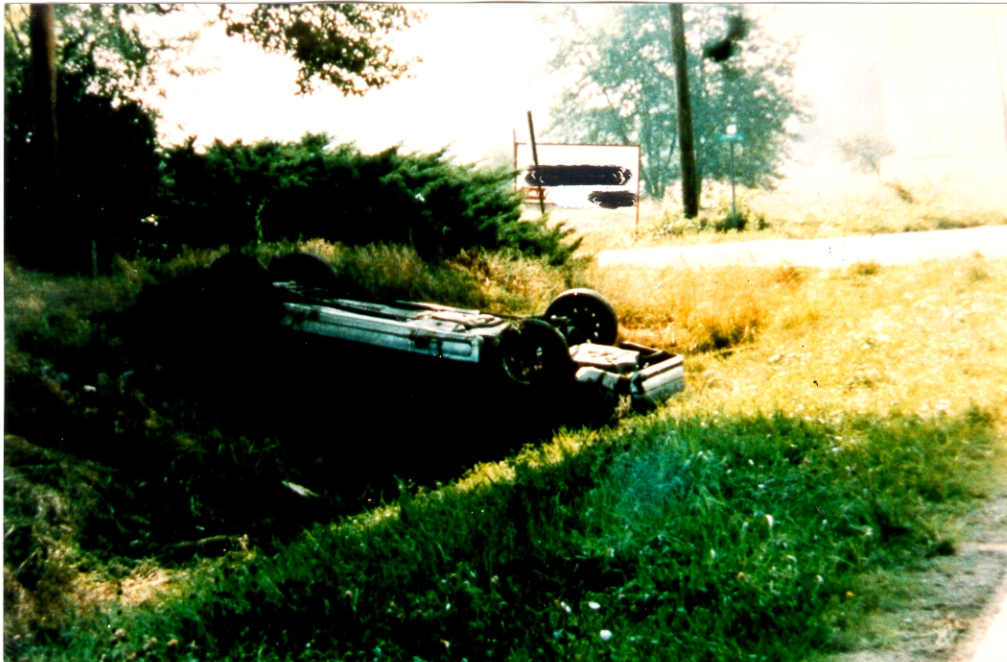
06 -- [REDACTED] 1993
 [REDACTED] Illinois
 TRC/IU: 93-07, Task: 0103
 ISP Photo: Daytona's final
 rest position facing north

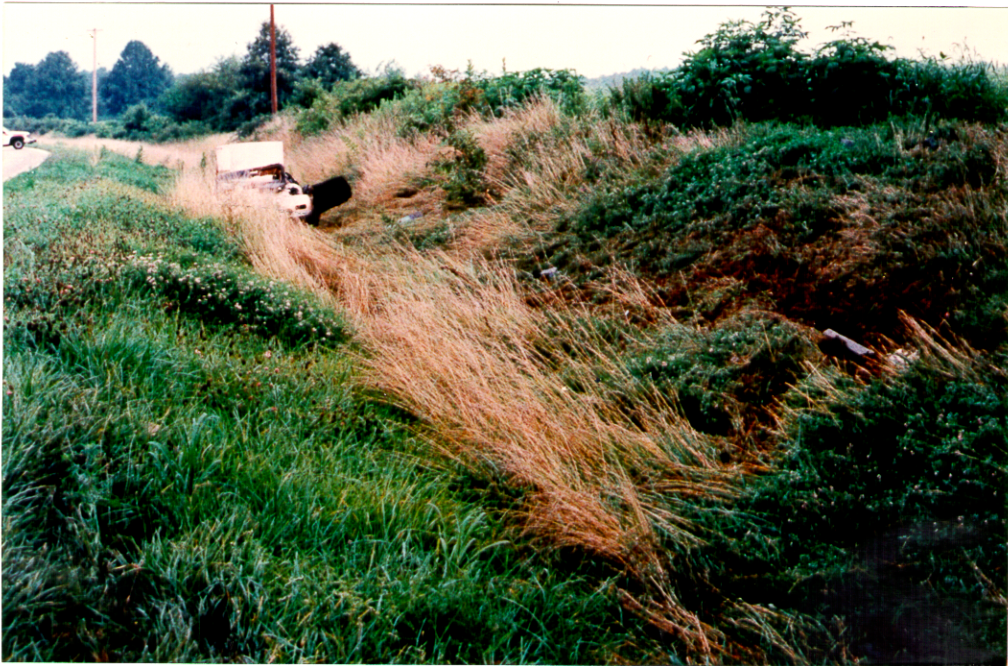
07 -- [REDACTED] 1993
 [REDACTED] Illinois
 TRC/IU: 93-07, Task: 0103
 ISP Photo: Fiero's impact
 with embankment & final rest

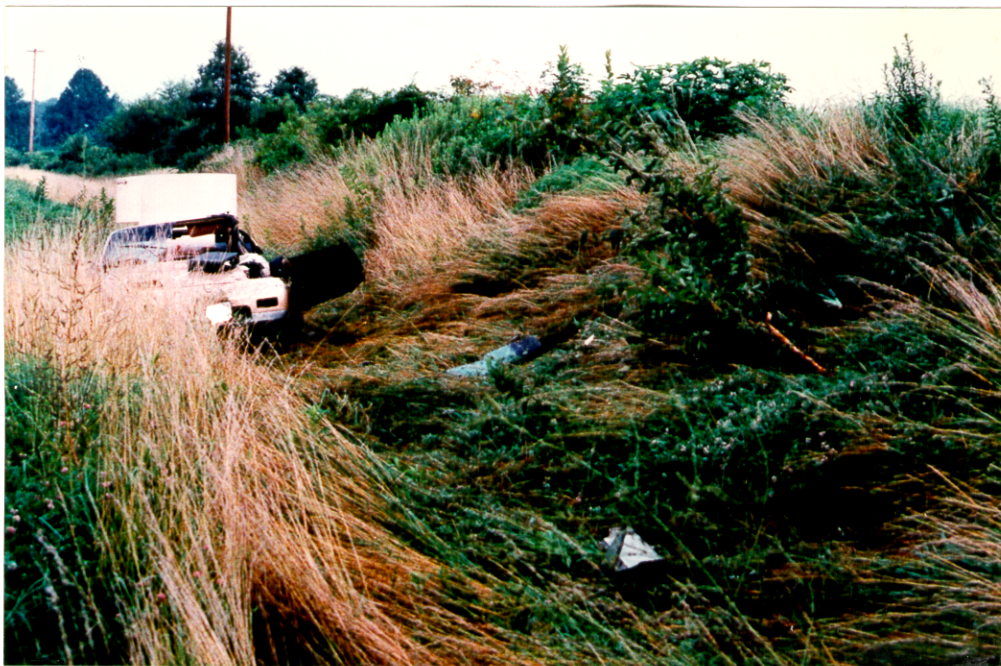
08 -- [REDACTED] 1993
 [REDACTED] Illinois
 TRC/IU: 93-07, Task: 0103
 ISP Photo: Fiero rotated
 CCW & went westward to FR

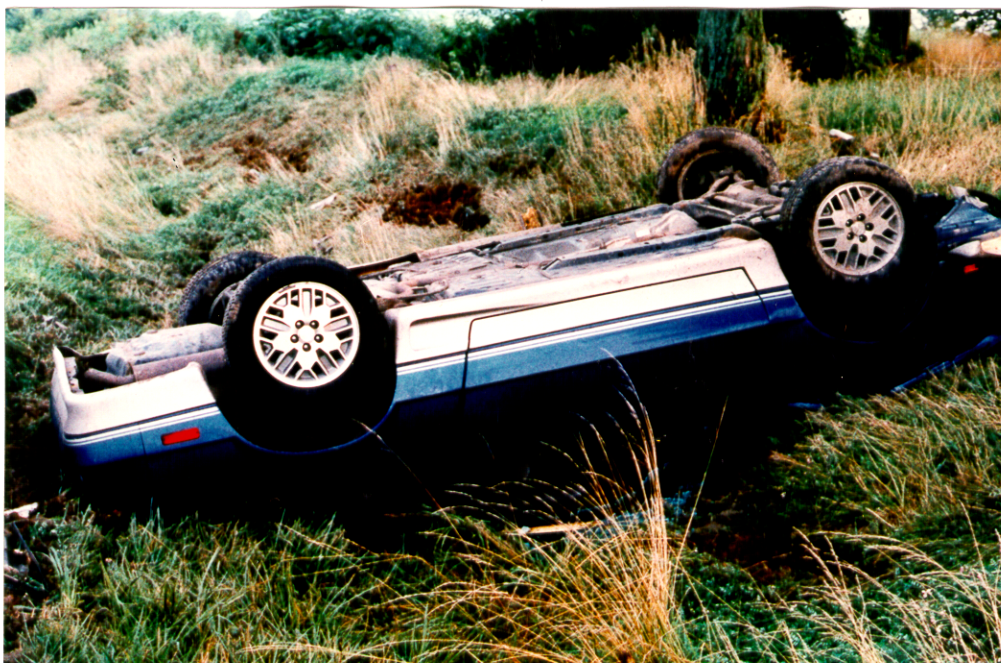
10 -- [REDACTED] 1993
 [REDACTED], Illinois
 TRC/IU: 93-07, Task: 0103
 ISP Photo: looking west at
 Daytona's FR facing north

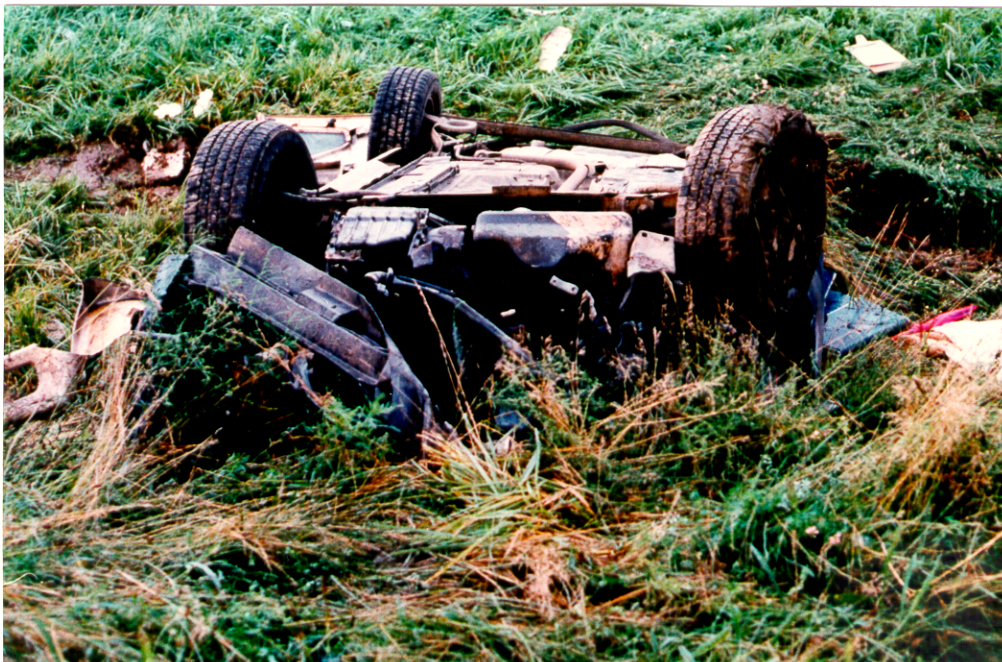
15 -- [REDACTED] 1993
 [REDACTED] Illinois
 TRC/IU: 93-07, Task: 0103
 ISP Photo: looking south at
 Daytona at final rest

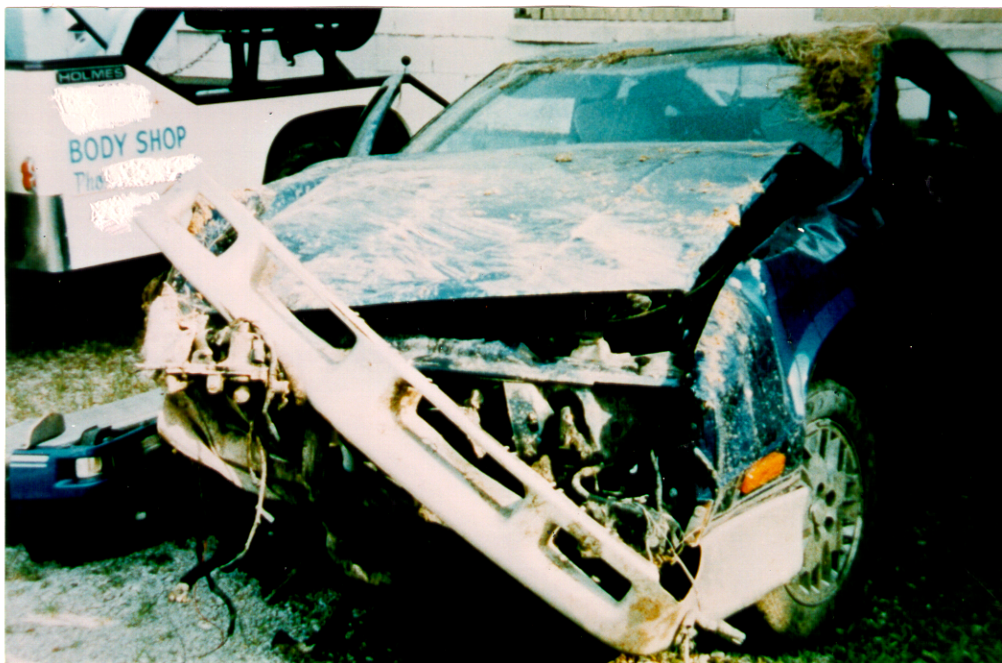
16 -- [REDACTED] 1993
 [REDACTED] Illinois
 TRC/IU: 93-07, Task: 0103
 ISP Photo: Daytona at body
 shop post removal from scene

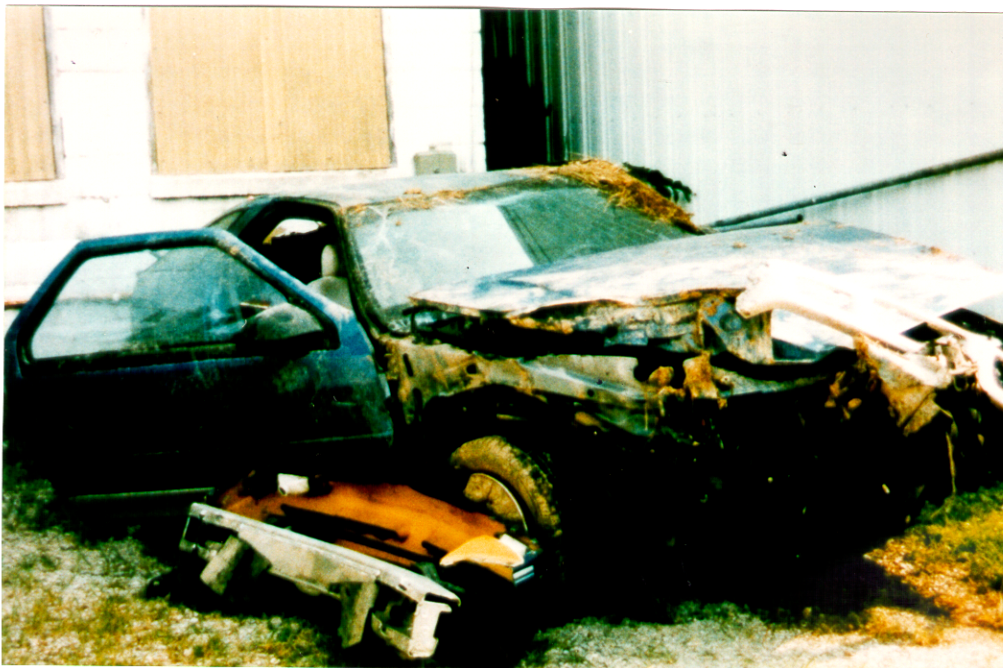
17 - [REDACTED], 1993
[REDACTED] Illinois
TRC/IU: 93-07, Task: 0103
ISP Photo: Daytona front &
right side at body shop

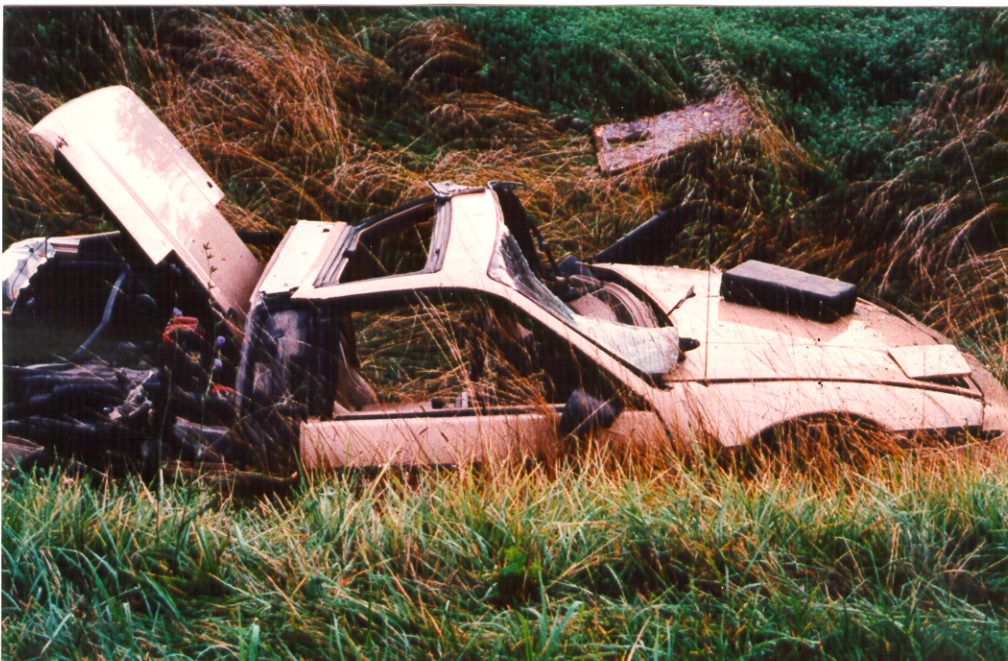
20 -- [REDACTED] 1993
 [REDACTED] Illinois
 TRC/IU: 93-07, Task: 0103
 ISP Photo: looking north at
 Fiero at FR facing east

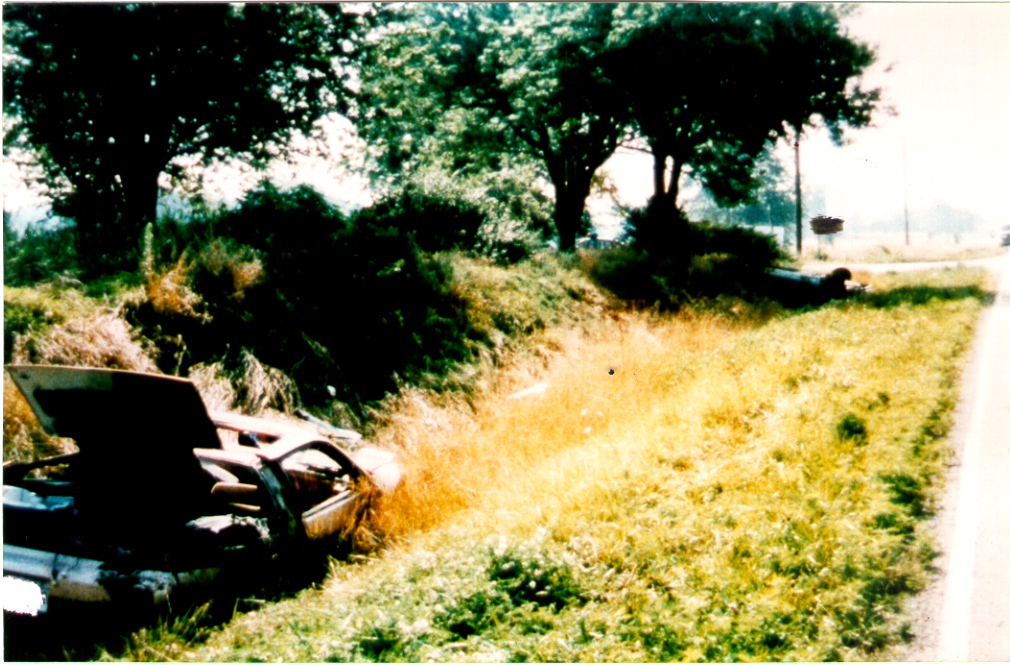
21 -- [REDACTED], 1993
 [REDACTED] Illinois
 TRC/IU: 93-07, Task: 0103
 ISP Photo: looking NE at
 proximity of Fiero & Daytona

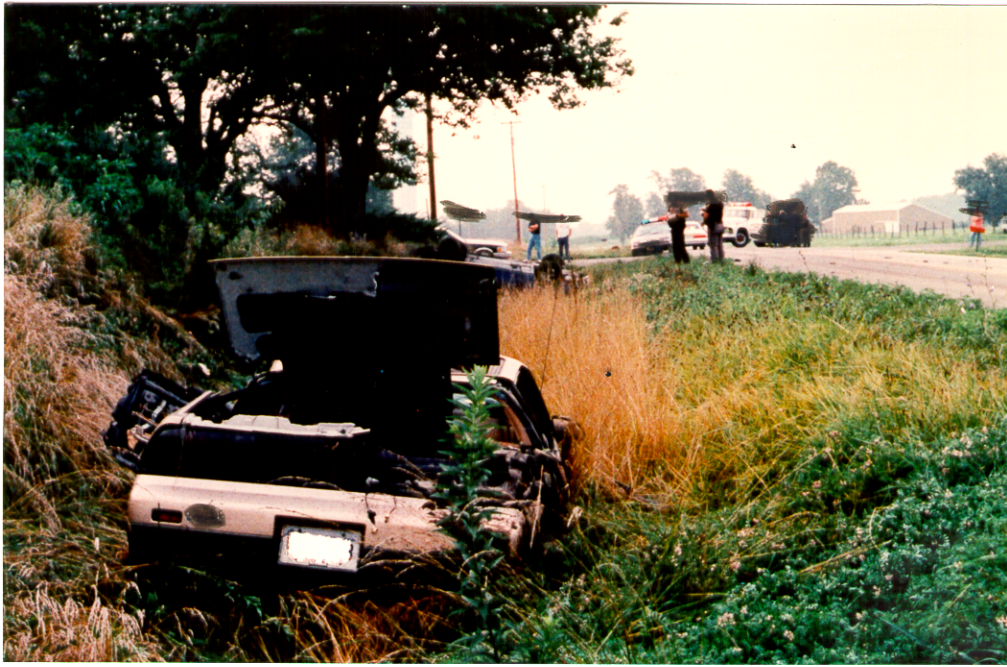
23 -- [REDACTED] 1993
 [REDACTED] Illinois
 TRC/IU: 93-07, Task: 0103
 ISP Photo: looking east at
 Fiero's final rest position

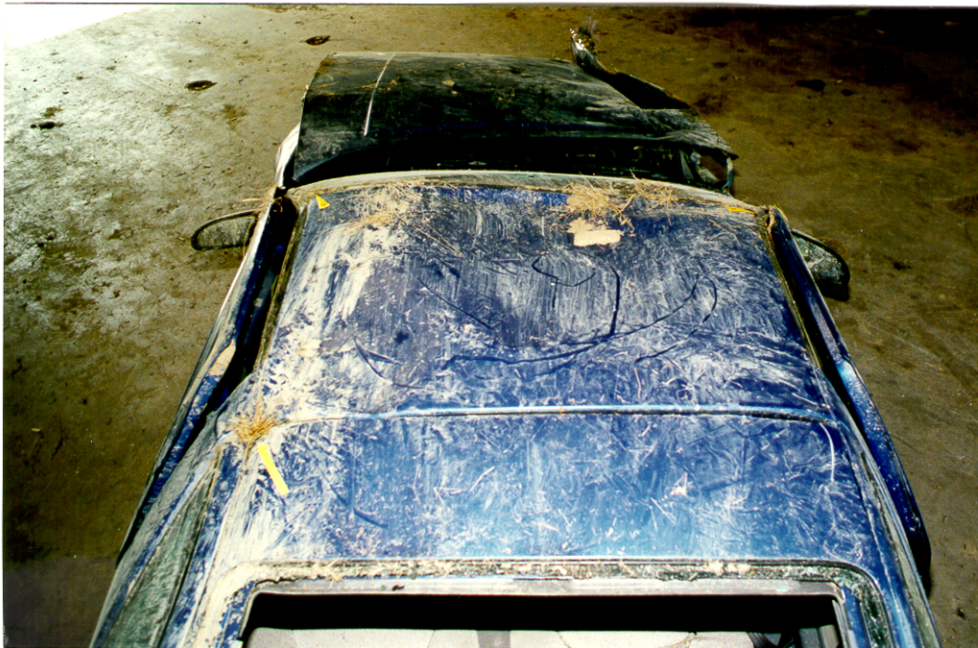
36 -- [REDACTED], 1993
[REDACTED], Illinois
TRC/IU: 93-07, Task: 0103
TRC Photo: rollover damage
of roof area from top-back

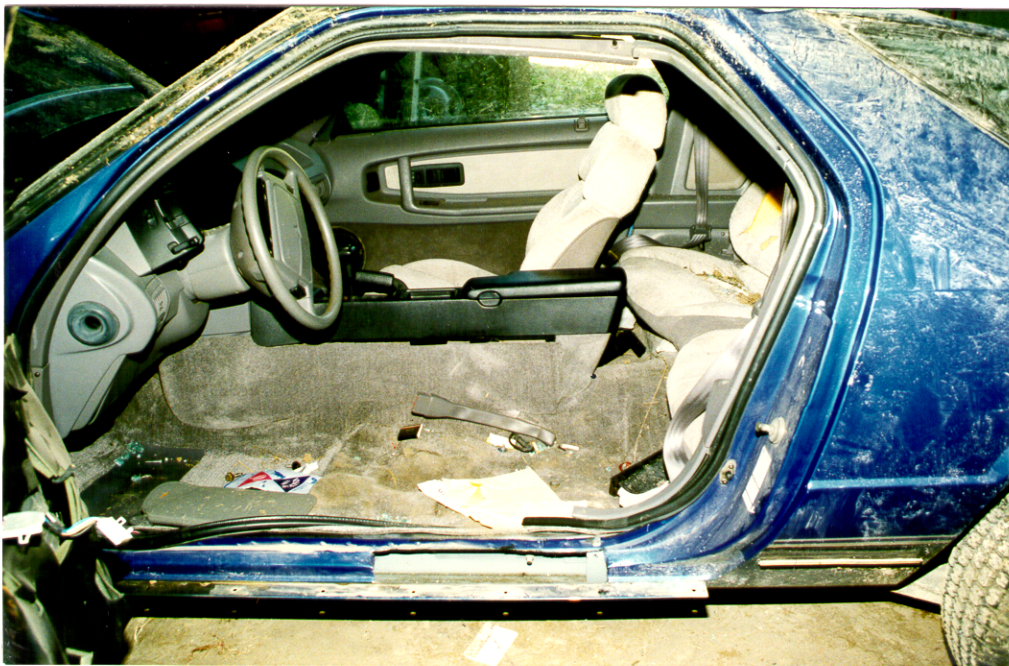
41 -- [REDACTED] 1993
 [REDACTED] Illinois
 TRC/IU: 93-07, Task: 0103
 TRC Photo: driver's area
 after seat removed by ISP

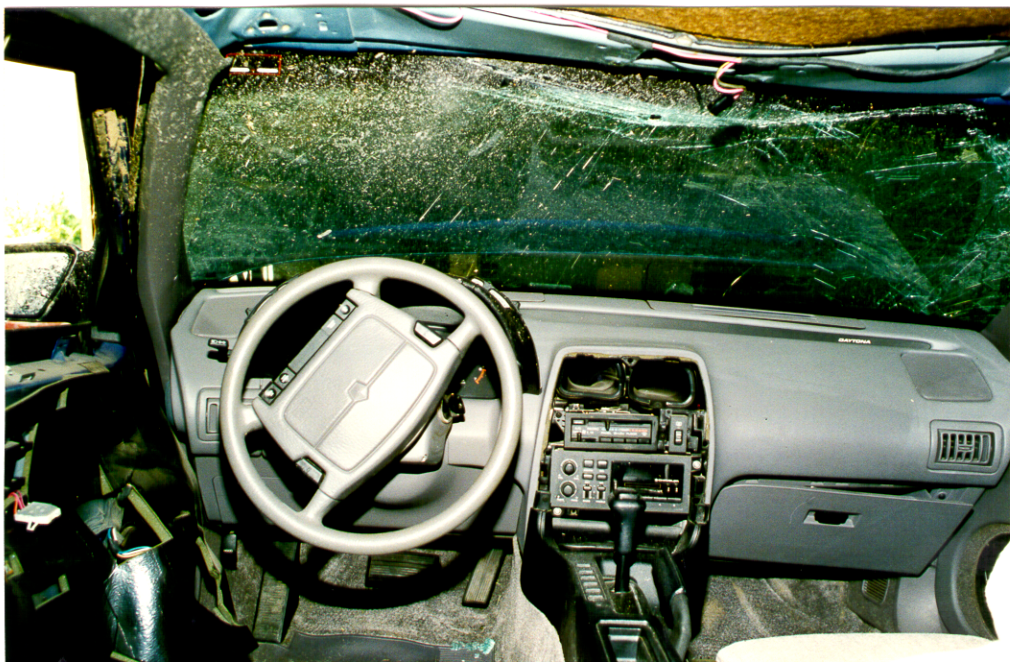
43 -- [REDACTED] 1993
[REDACTED], Illinois
TRC/IU: 93-07, Task: 0103
TRC Photo: steering wheel &
instrument panel

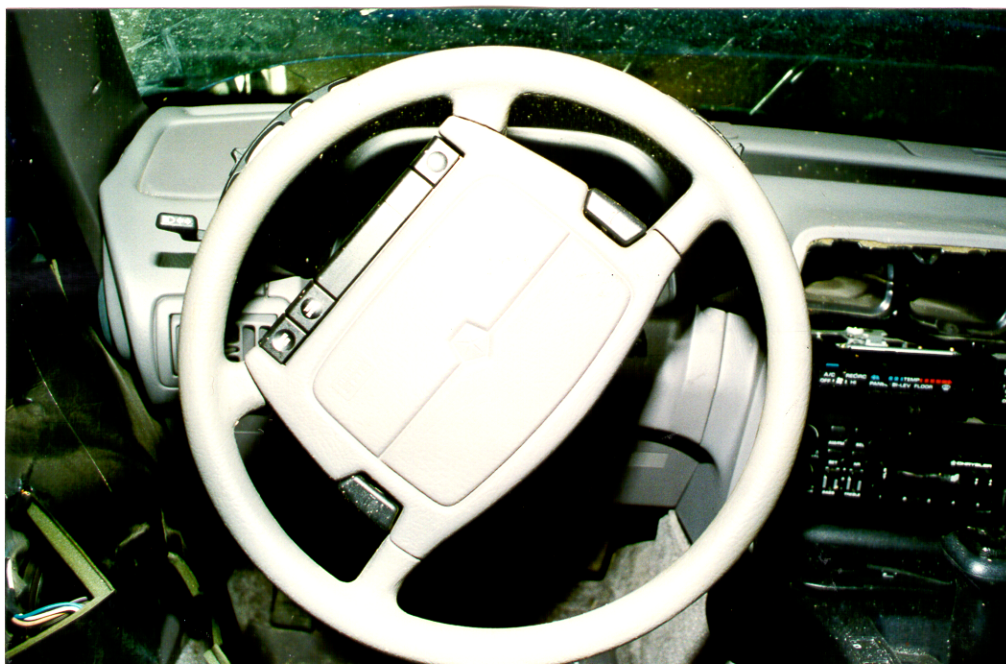
44 -- [REDACTED] 1993
[REDACTED], Illinois
TRC/IU: 93-07, Task: 0103
TRC Photo: closeup steering
wheel & air bag cover

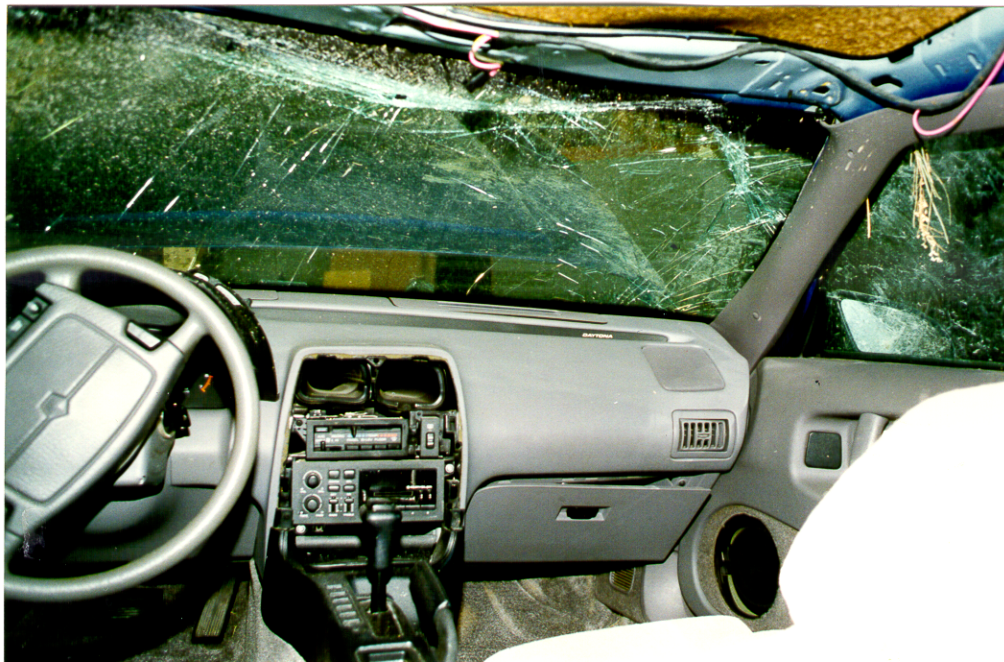
46 - [REDACTED] 1993
 [REDACTED], Illinois
 TRC/IU: 93-07, Task: 0103
 TRC Photo: center & right
 instrument panel areas

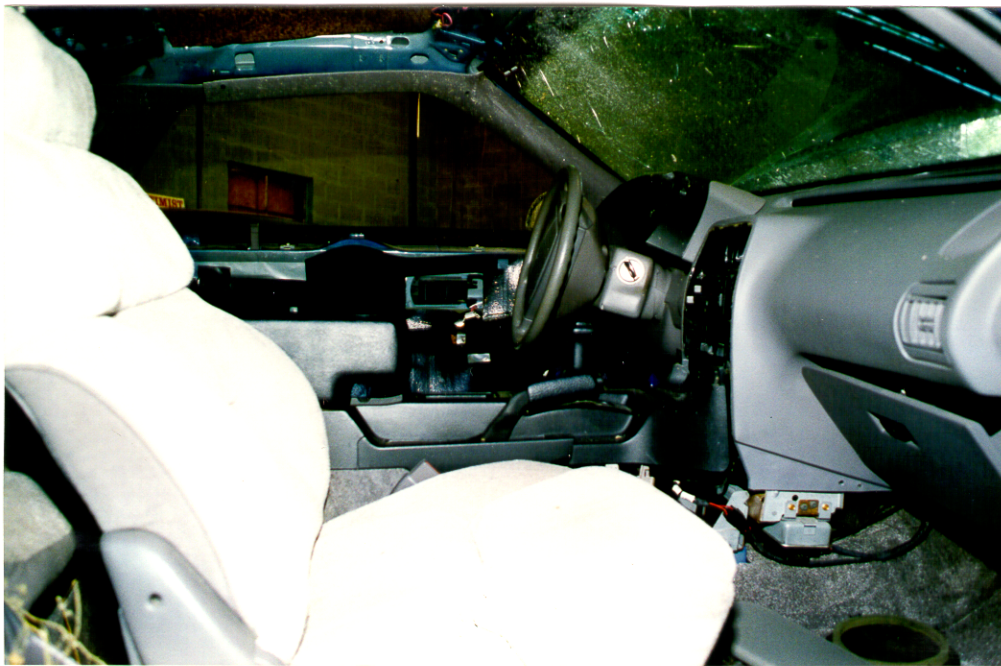
47 - [REDACTED] 1993
 [REDACTED], Illinois
 TRC/IU: 93-07, Task: 0103
 TRC Photo: driver's area
 from right front door

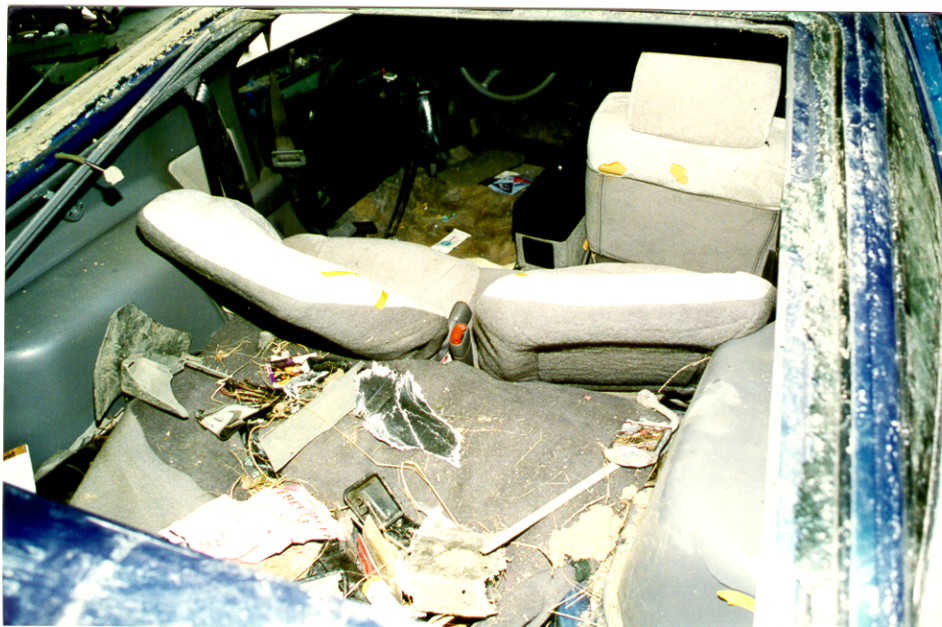
50 -- [REDACTED] 1993
[REDACTED] Illinois
TRC/IU: 93-07, Task: 0103
TRC Photo: bent rear seats
from back through backlight

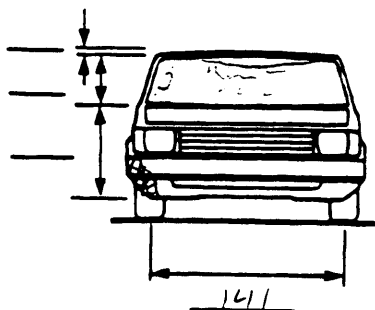
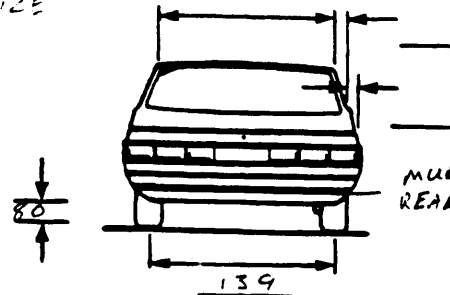
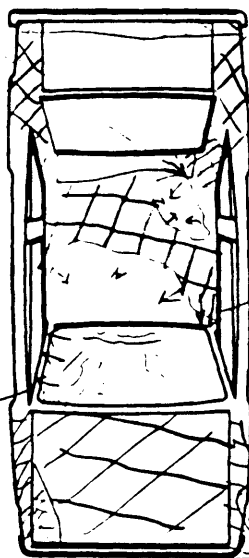
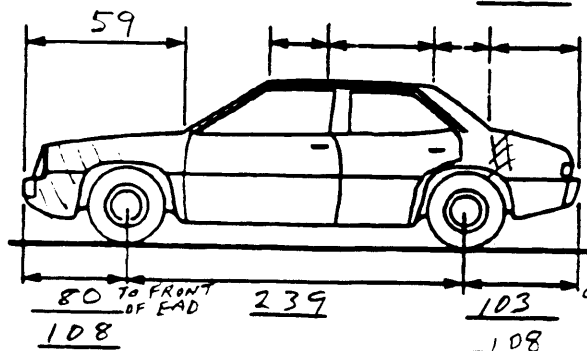
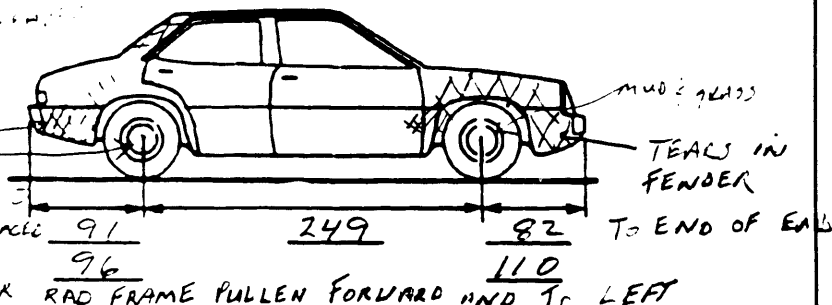
REAR LIGHTS BROKEN
 out By POLICE

GRASS IN SEAM BETWEEN HATCH AND ROOF

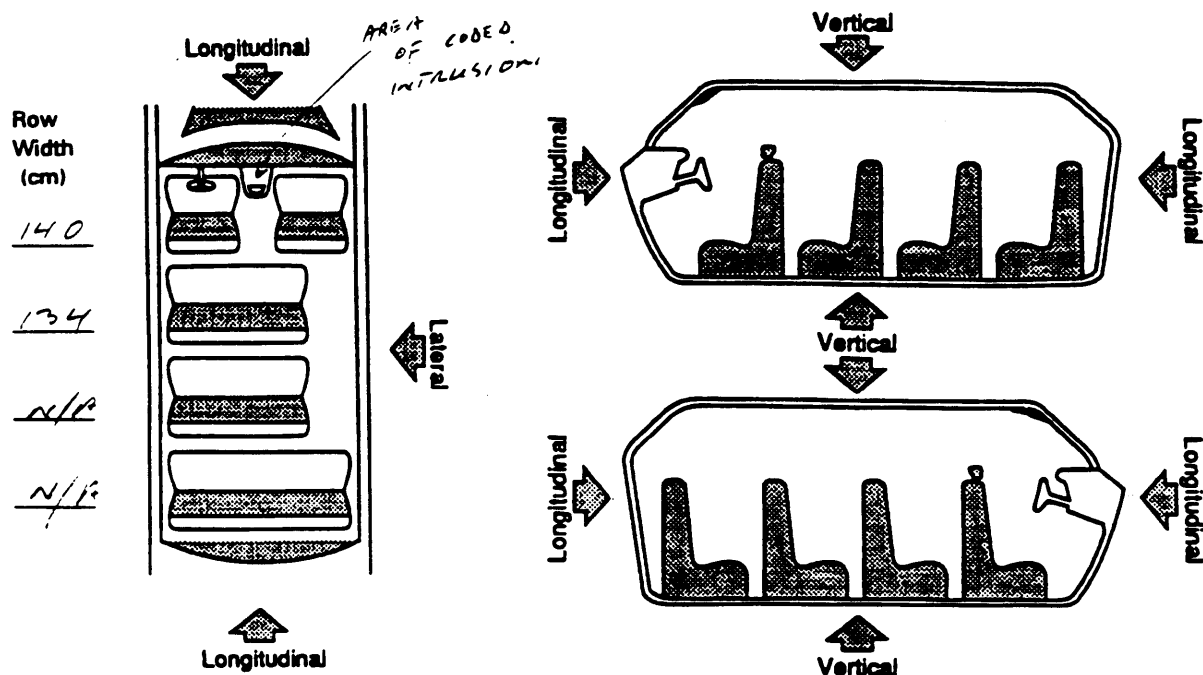
INTRUSION WORKSHEET

LOCATION OF INTRUSION	INTRUDED COMPONENT	(All Measurements Are In Centimeters)			INTRUSION	DOMINANT CRUSH DIRECTION
		COMPARISON VALUE	INTRUDED VALUE	=		
11	ROOF	34	33.5	= .5		
11	W/S HEADER	33	32.5	= .5		
11	WINDSHIELD	34	34.5	= .5		
12	ROOF	34	31	= 3	VERT	
12	W/S HEADER	33	30	= 3	VERT	
12	WINDSHIELD	35	33	= 2		
13	ROOF	CLEARLY < 3cm			=	
13	W/S HEADER			=		
13	WINDSHIELD			=		
21	ROOF			=		
21	ROOF SIDE RAIL			=		
21	BACKLIGHT HEADER		✓	=		
22	" "			=		
				=		
				=
